# Monitoring and Evaluation of Plate Girder Bridges with Fatigue Problems

Douglas Wood, Brent M. Phares, Terry J. Wipf,  
Lowell Greimann, David Tarries  
Iowa State University

# Overview

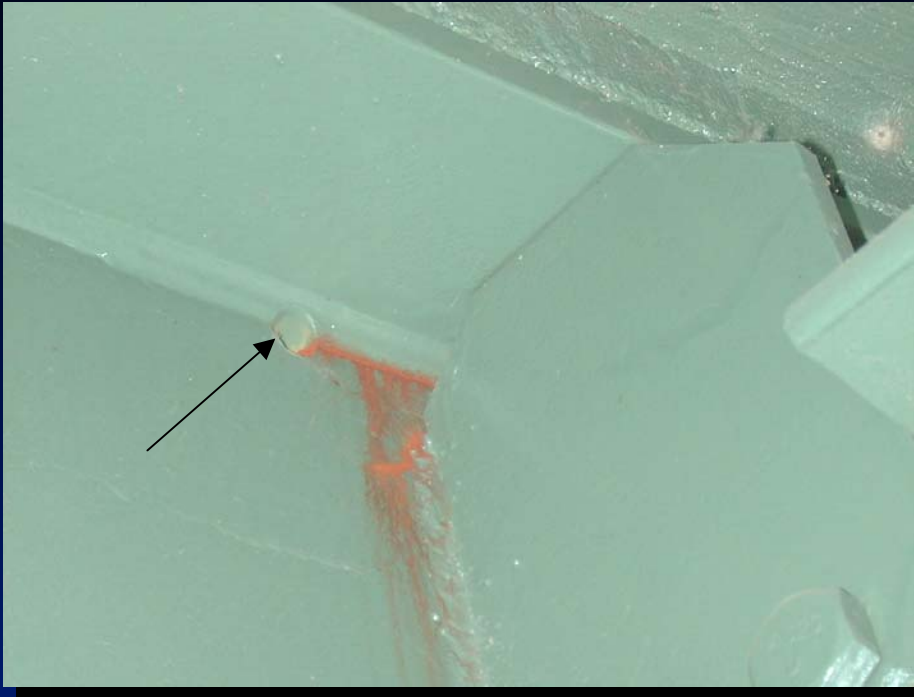
# The Retrofit

- Loosen bolts in diaphragm/ girder connections in negative moment region.
- Leave diaphragms in place to support girders.

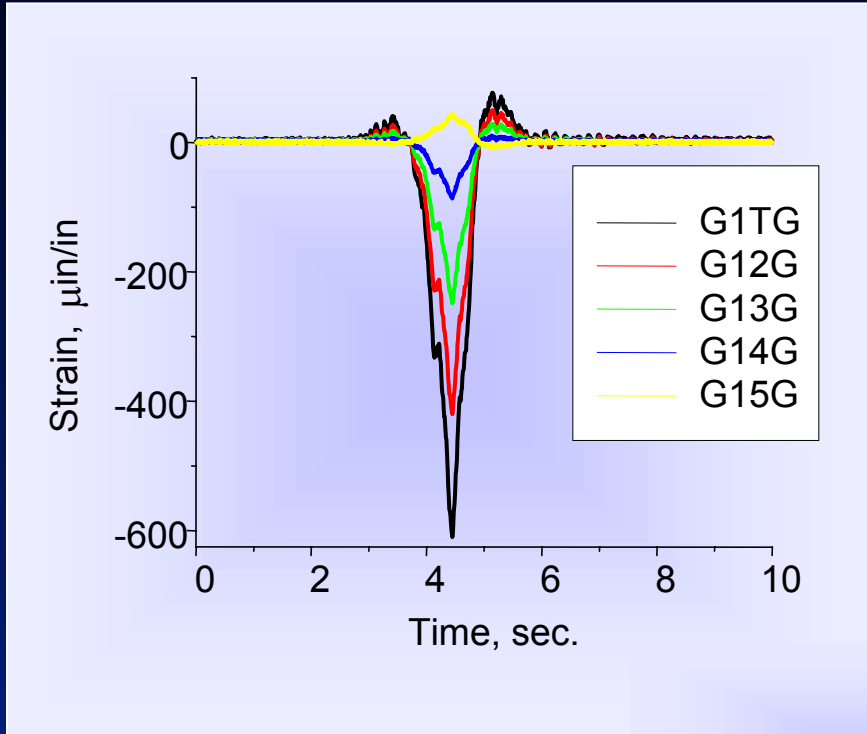
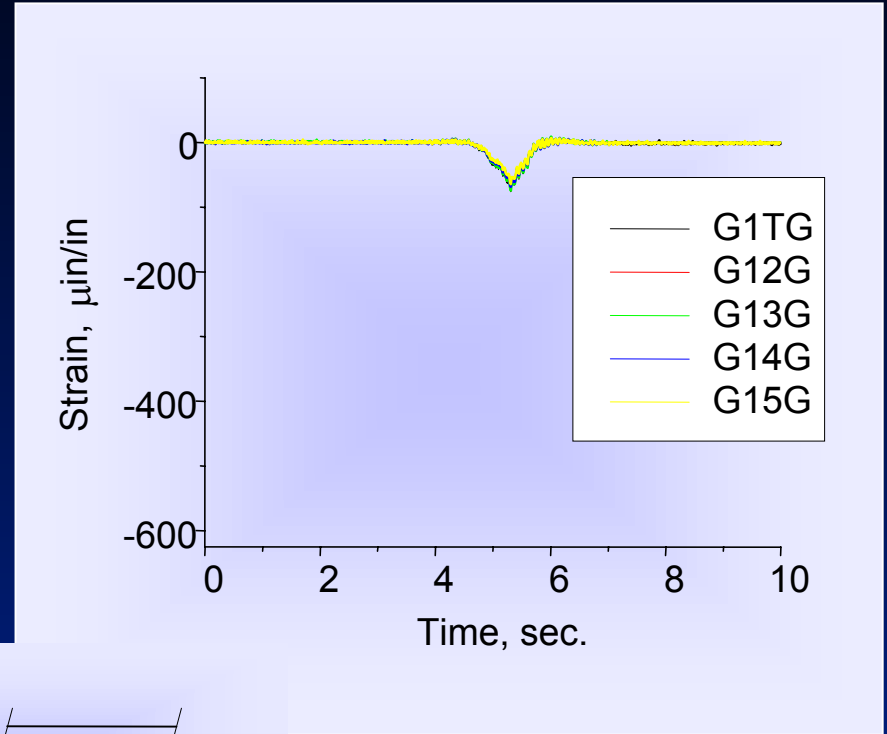
# Web Gap Strain

Tight

Loose

- Collected data showed a reduction in strain in the web gap resulting from the retrofit of approximately 75%.
- Long-term data trends suggest the effectiveness of the retrofit is not affected over time by vibrations and temperature changes.

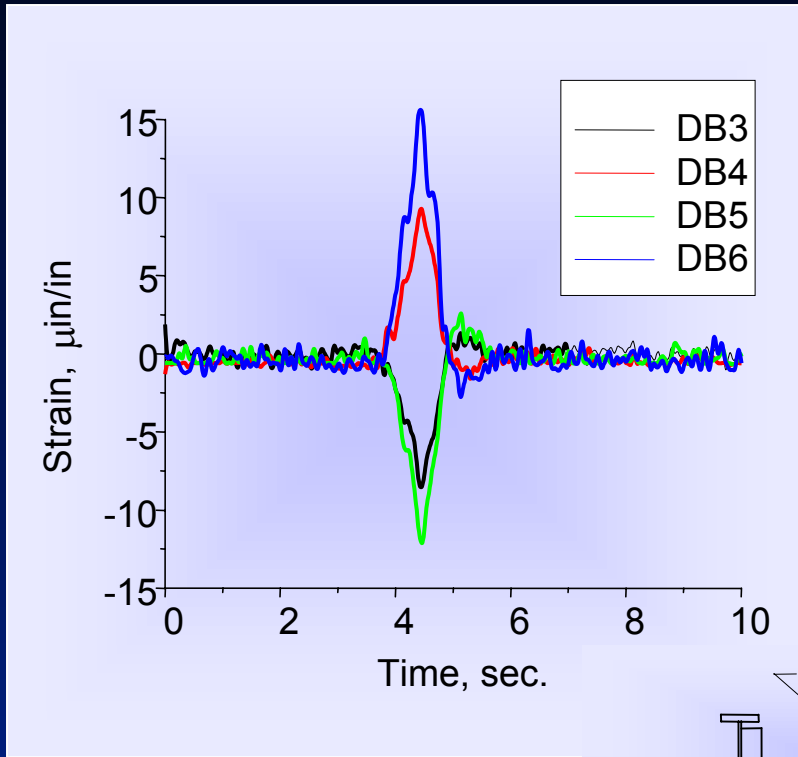
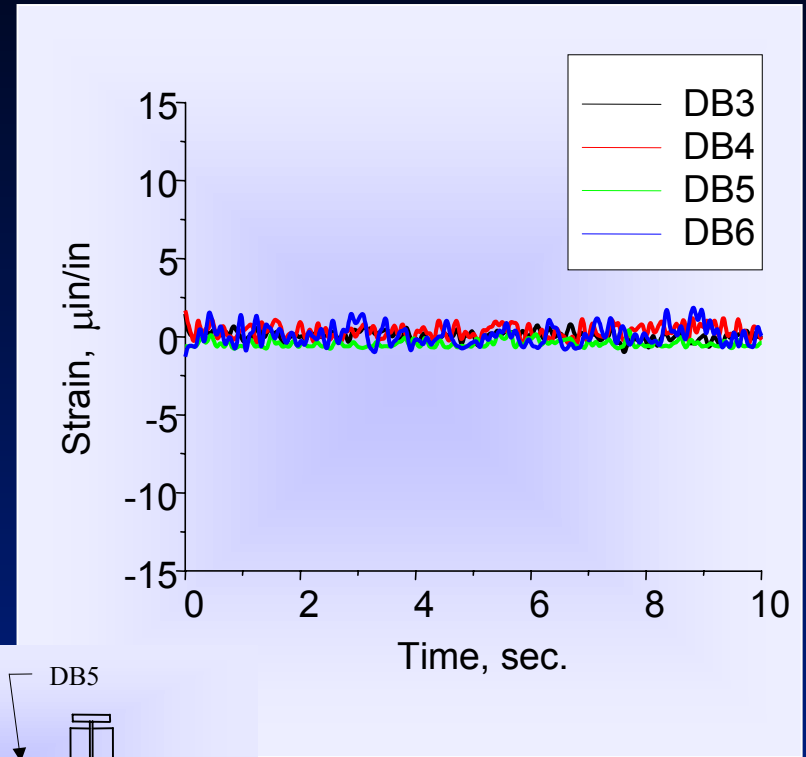
# Diaphragm Strain

Tight

Loose

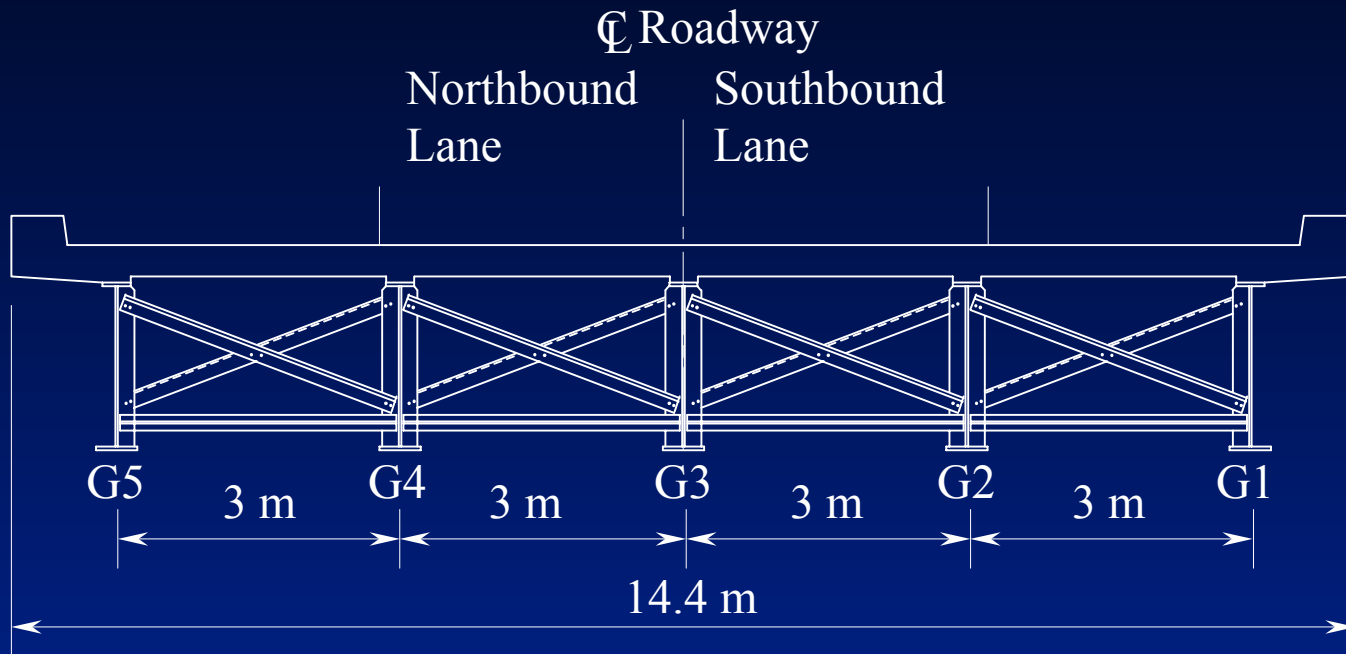
# Bridge Cross-Section

- Three span, five girder bridge with X-type cross-bracing.
- Long-term testing.

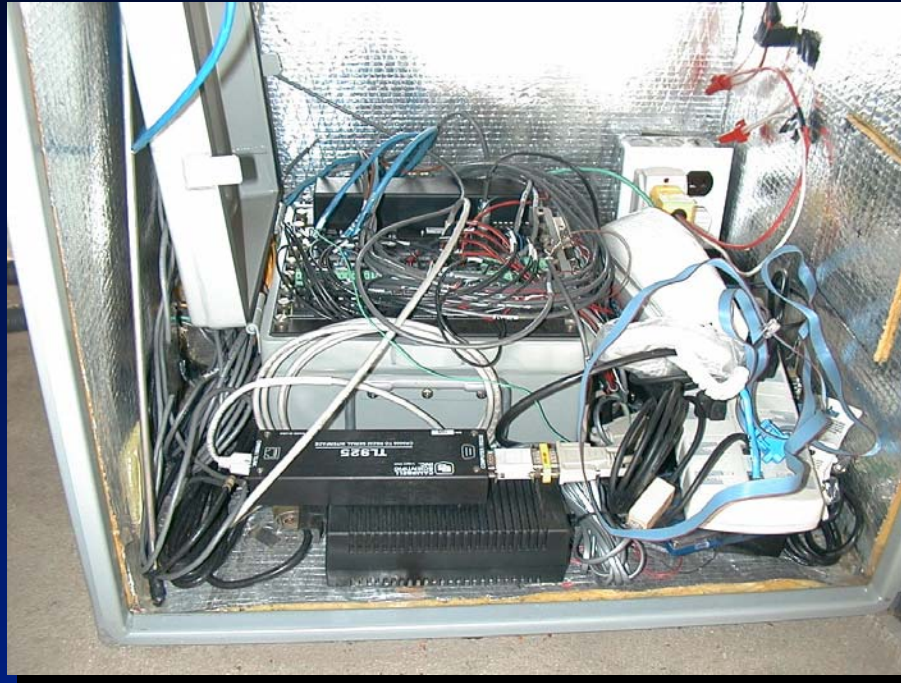
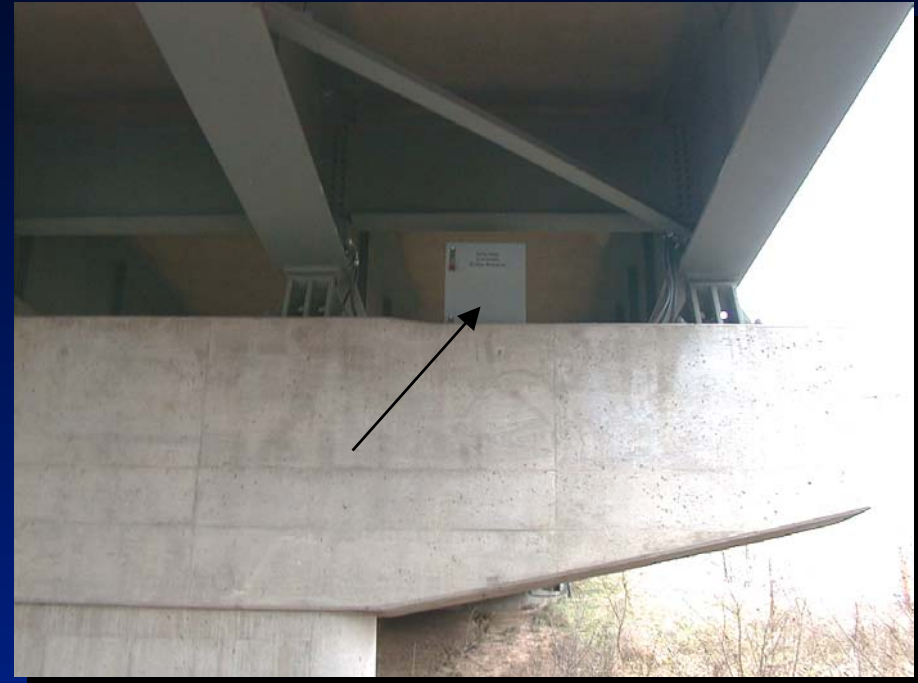
# Health Monitoring System

- A Campbell Scientific CR 9000 was selected for remote monitoring of ambient truck traffic on the bridge.
- Strain gages, displacement transducers, and thermocouples were installed and connected to the CR 9000.

- 24 input channels.
- Connected to local power grid for continuous operation.
- Phone line installed to allow data acquisition and program adjustments.
- Trigger programmed into system to collect only data larger than a designated threshold set to register truck loads.

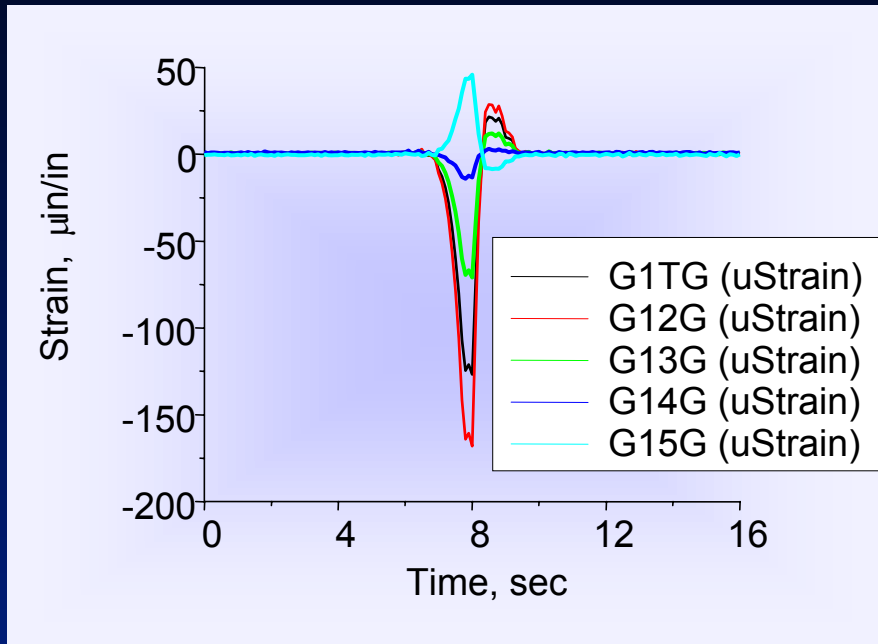
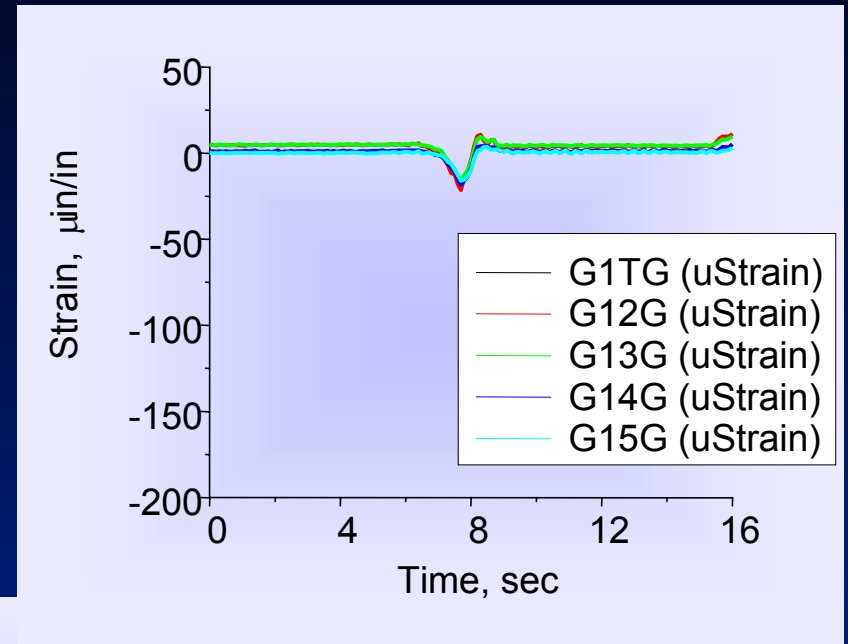
# Web Gap Strain Gradient

Tight

Loose

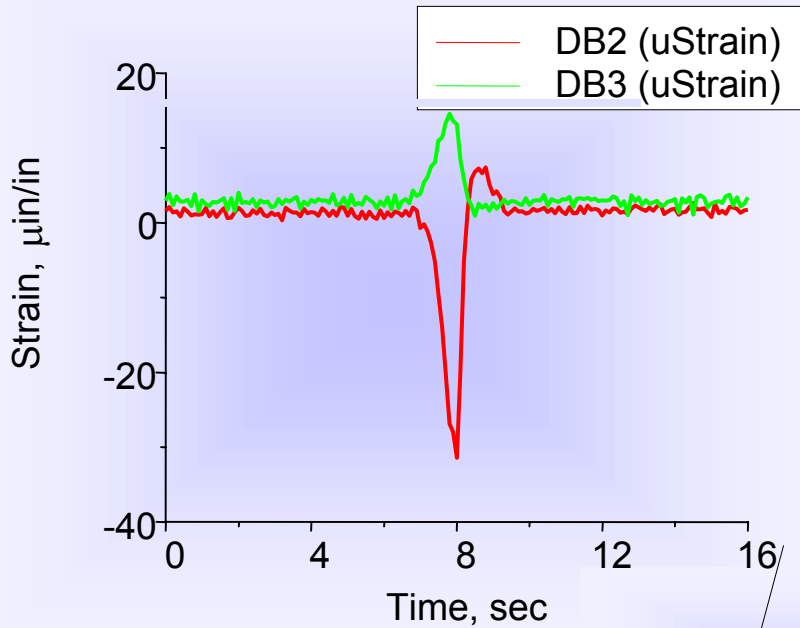
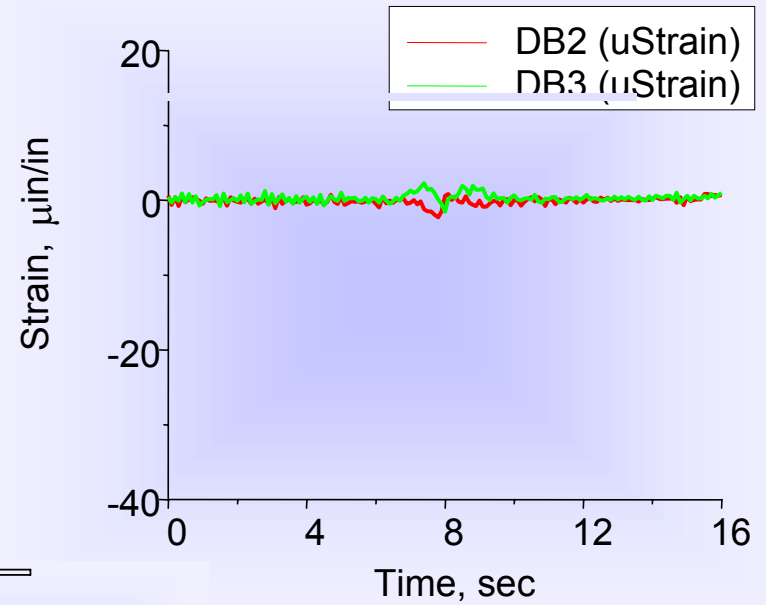
# Cross-Frame Behavior

Tight

Loose

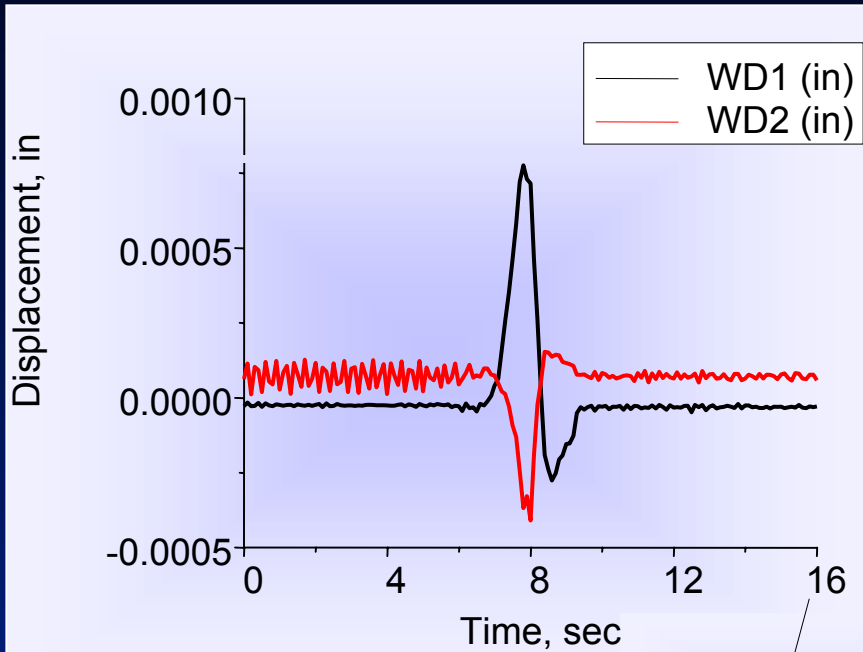
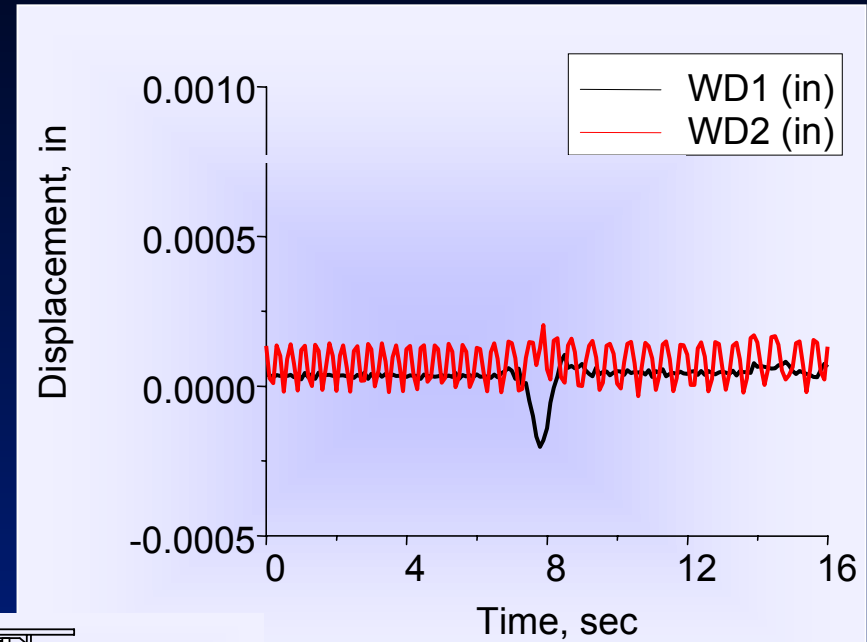
# Out-of-Plane Displacement

Tight

Loose

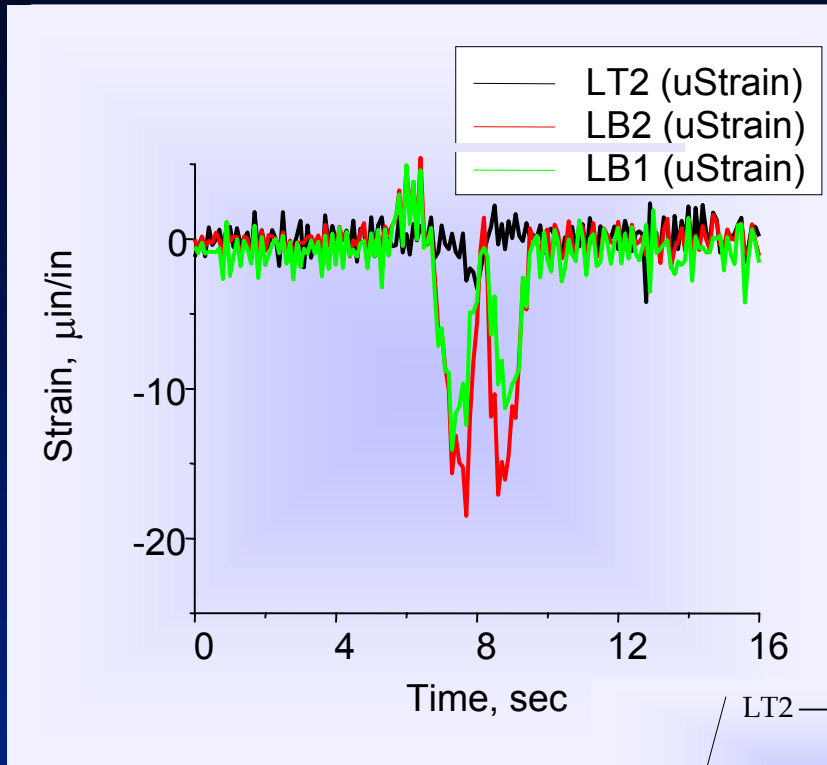
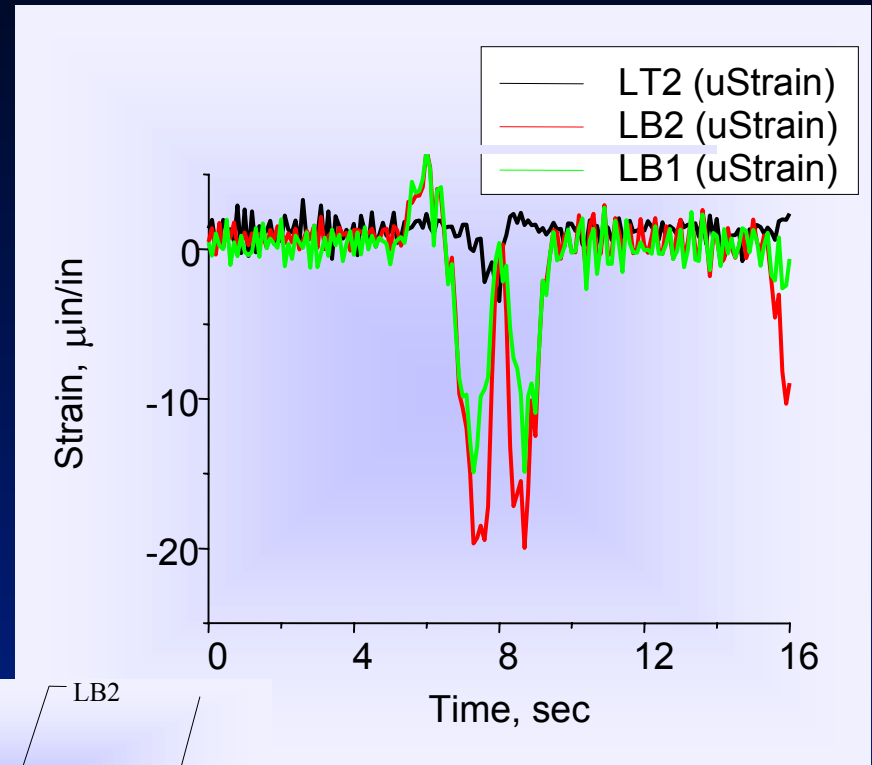
# Bottom Flange-Trigger Data

Tight

Loose

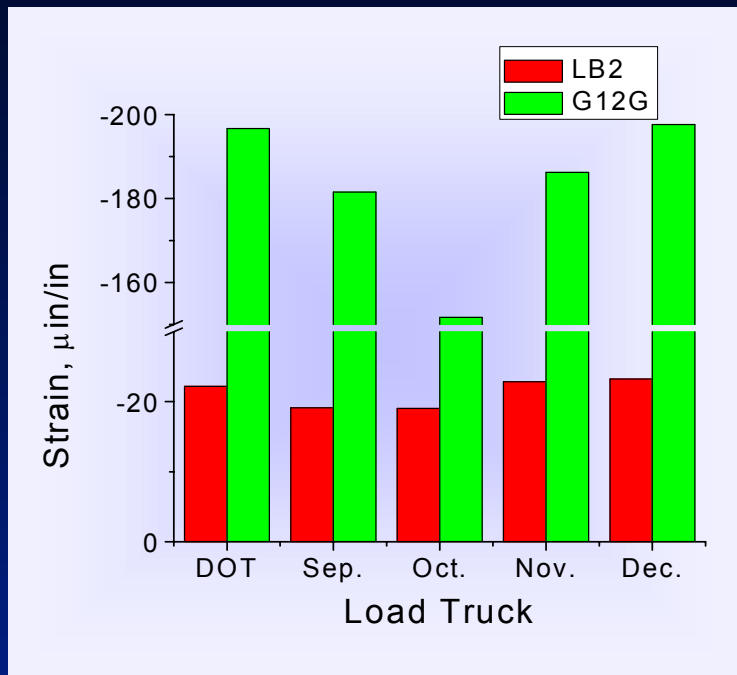
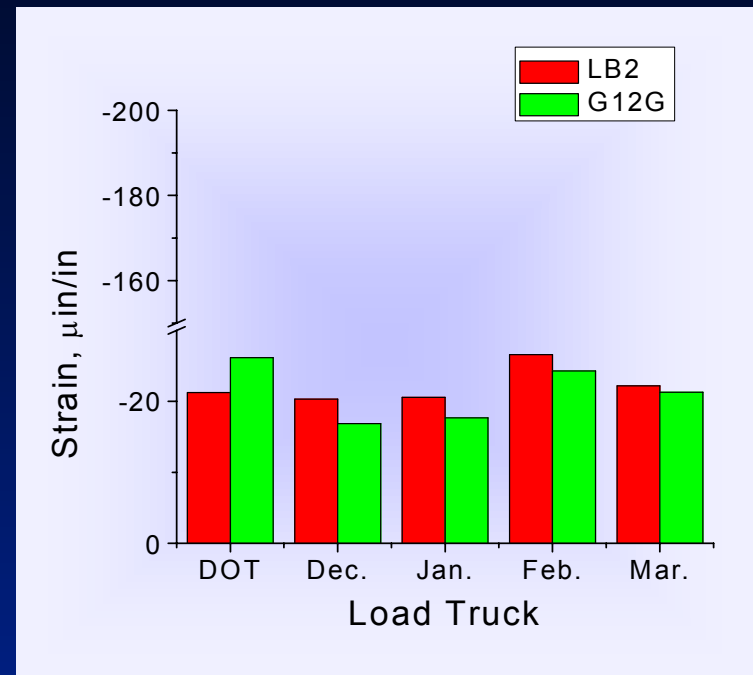
# Loading Variability

Tight

Loose
